SERENA

Progress Report

Week of 10/02/2020

Location: Rybovich, Riviera, Florida (North Yard)

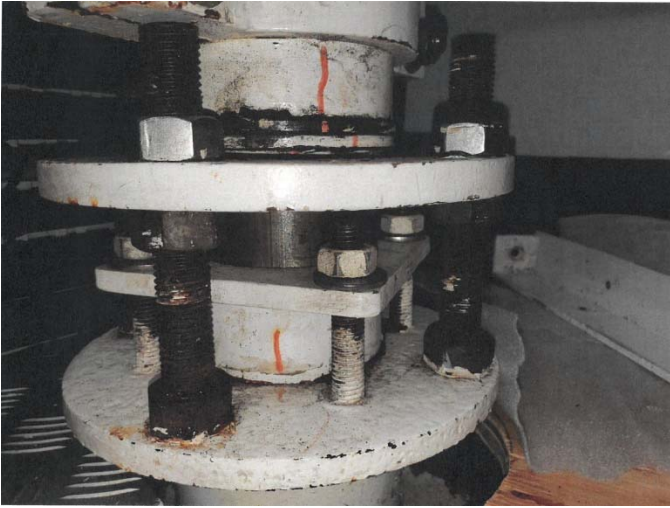
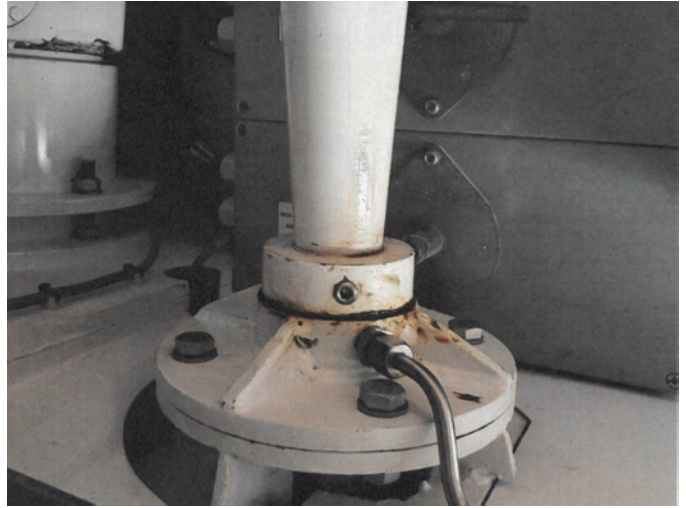
Rudders removal

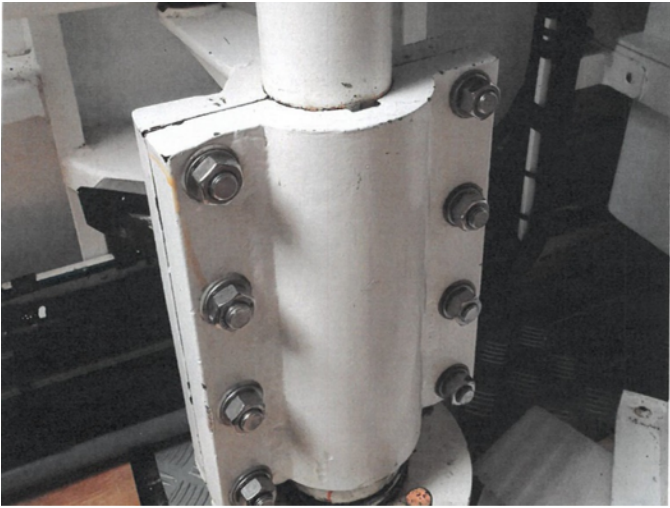
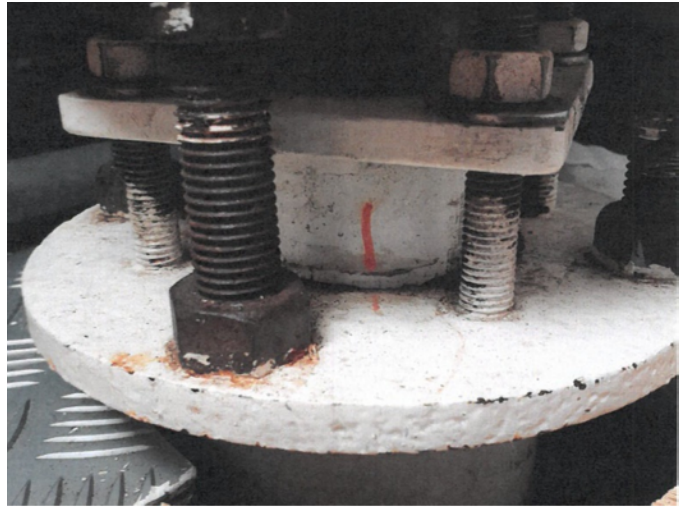
Rudders removal

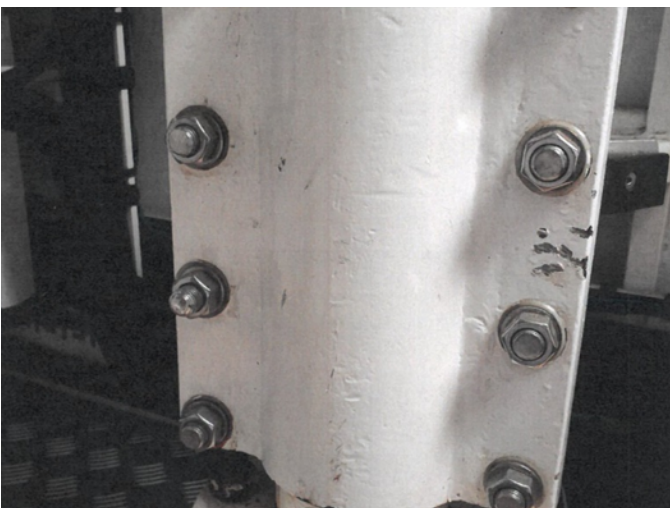
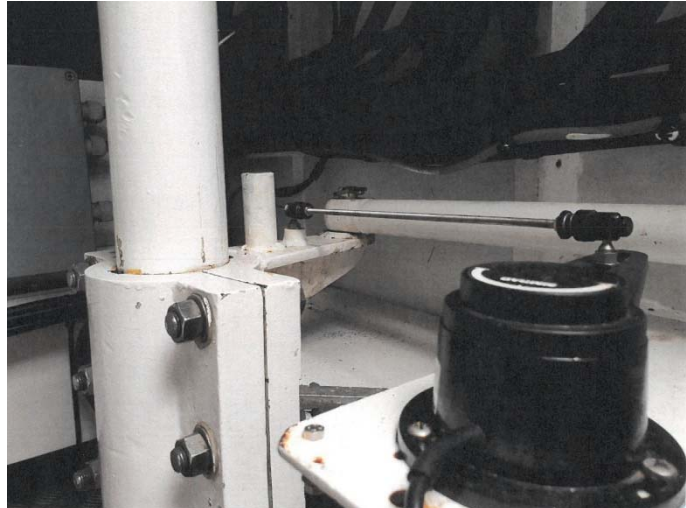
Rudders removal

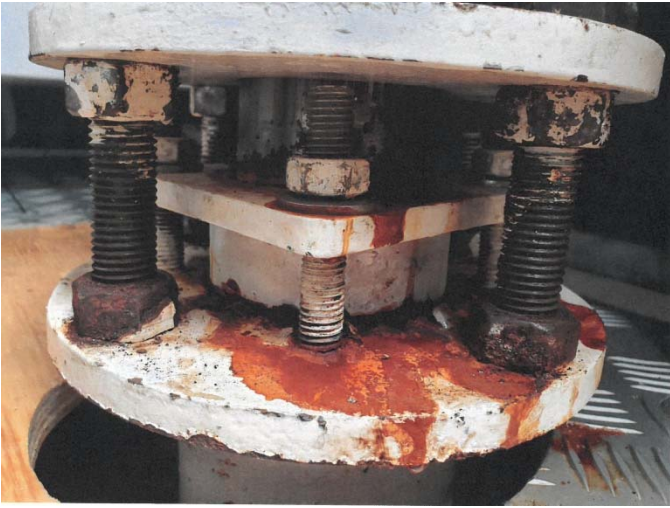
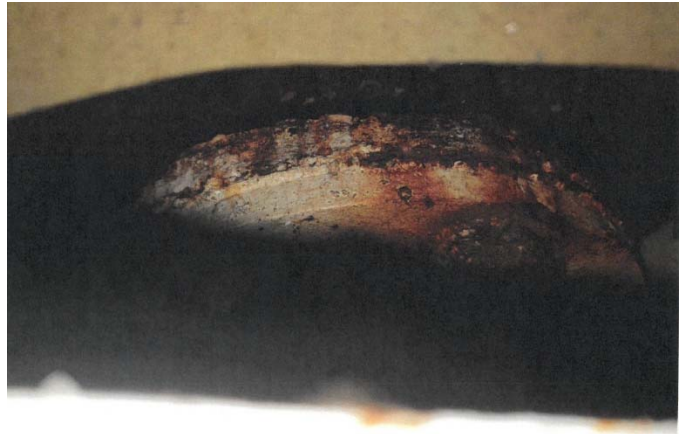
Rudders removal

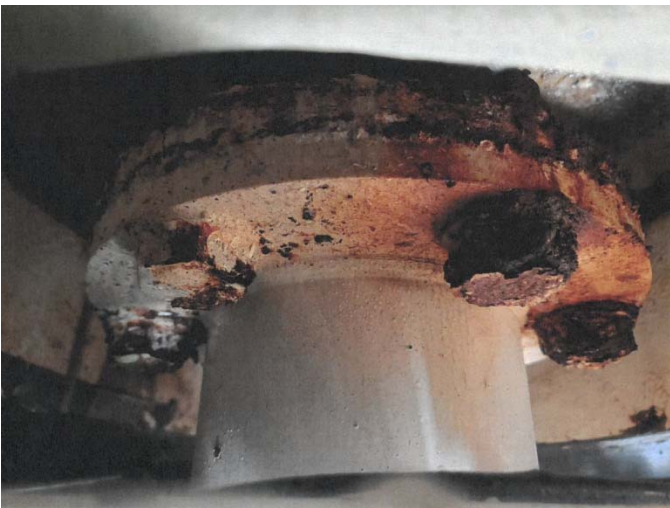
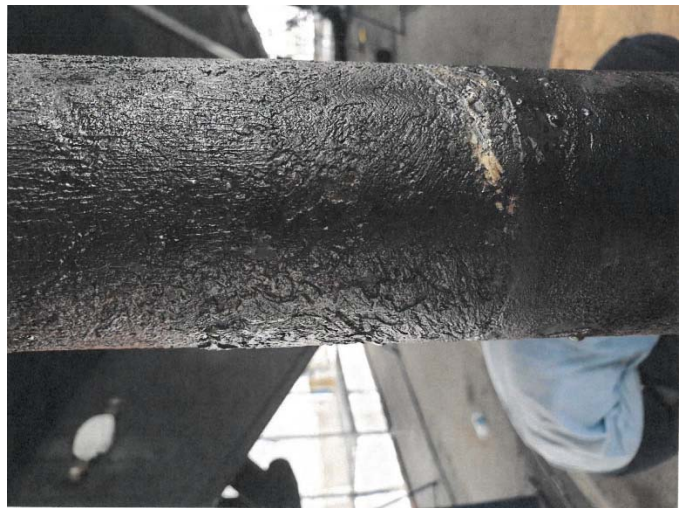
Rudders removal

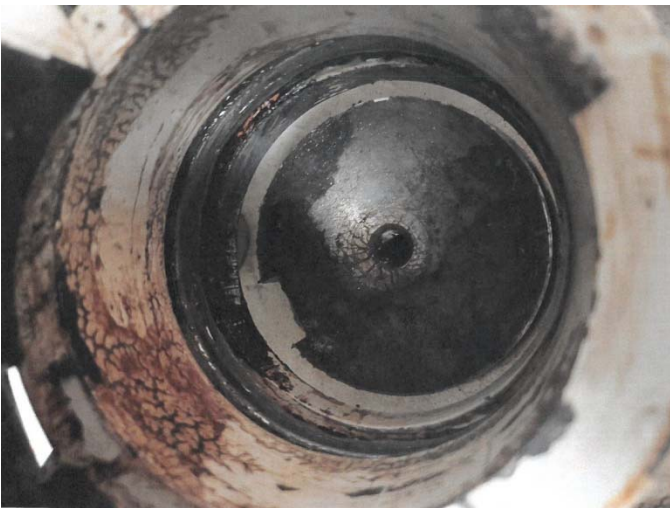
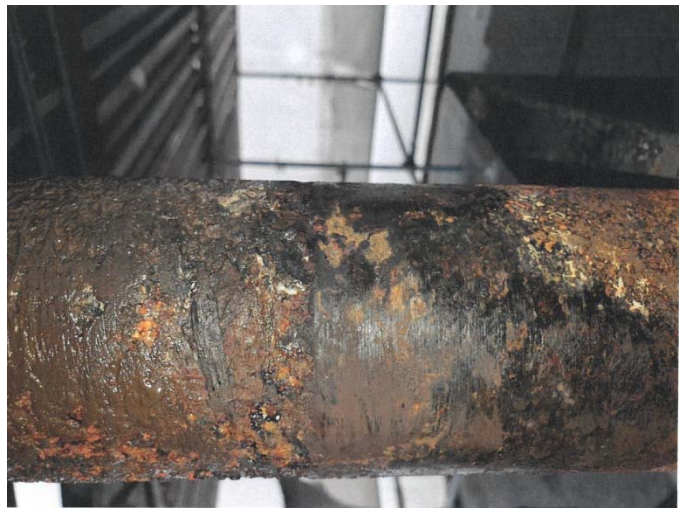
Rudders removal

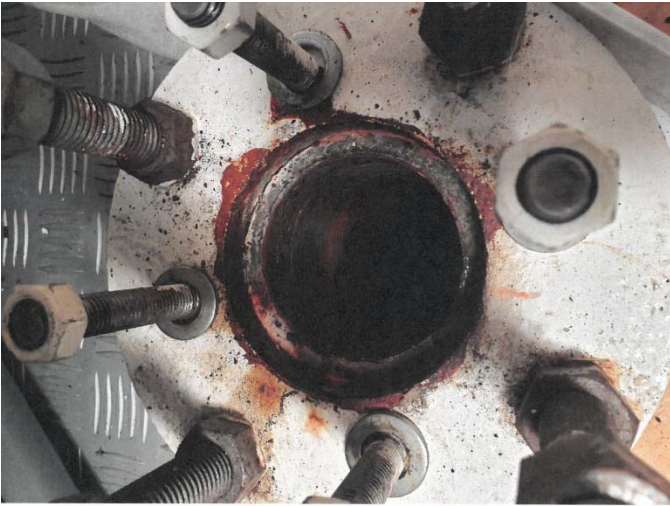
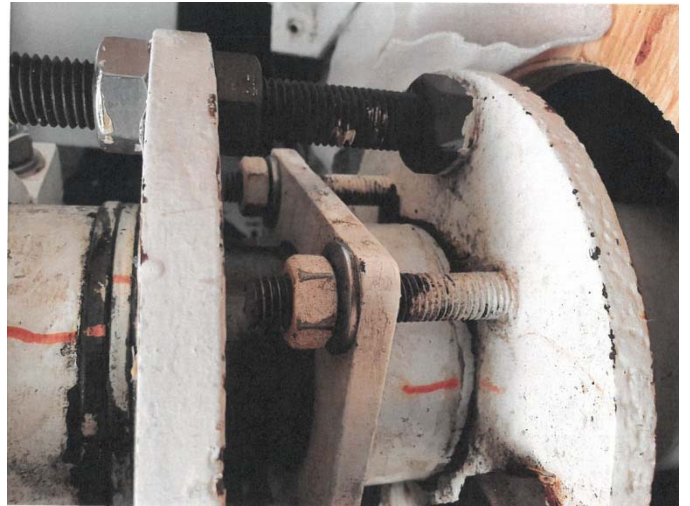
Rudders removal

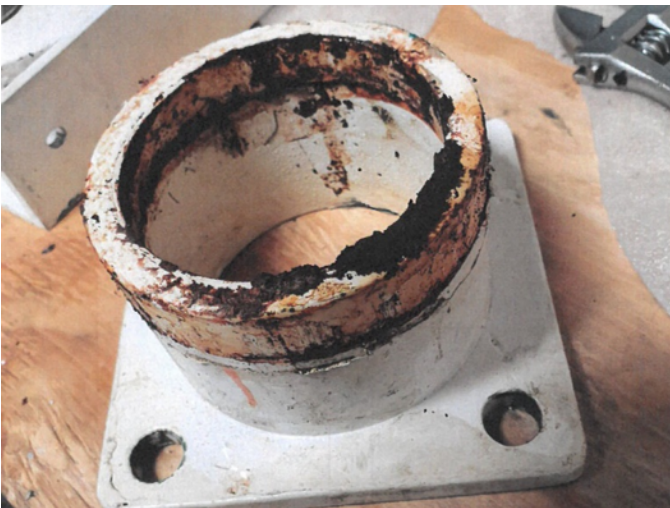
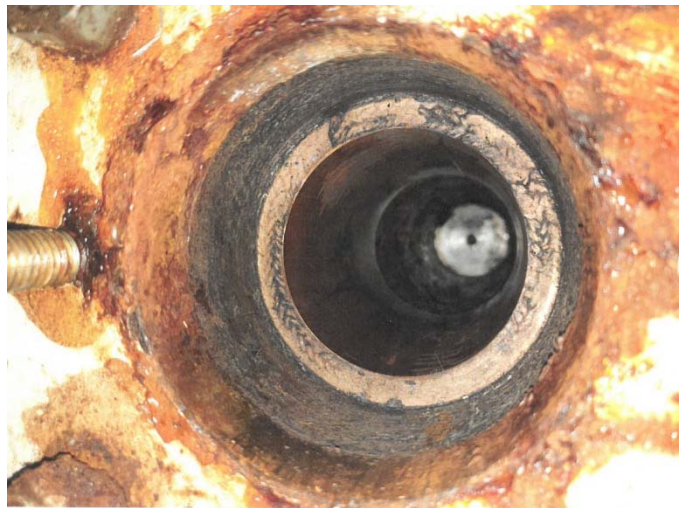
Rudders removal

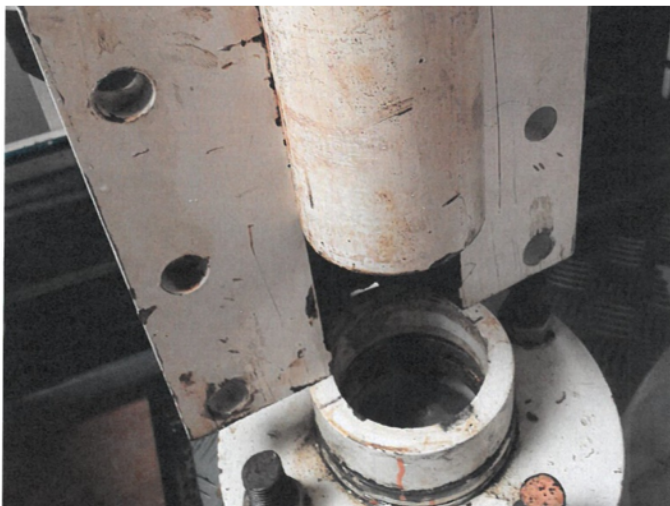
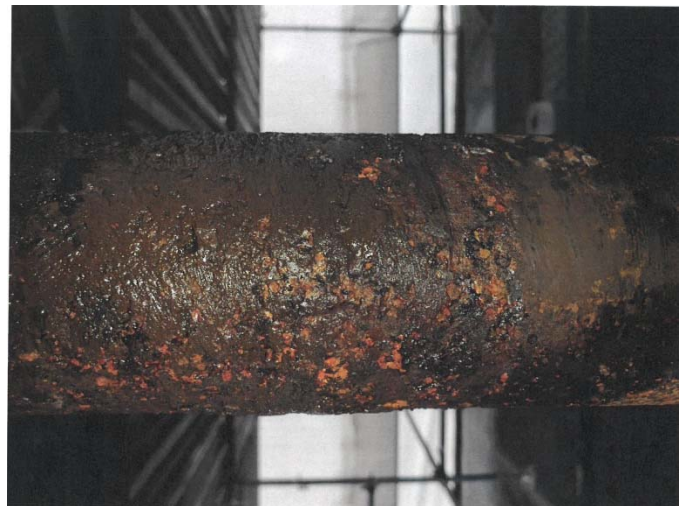
Rudders removal

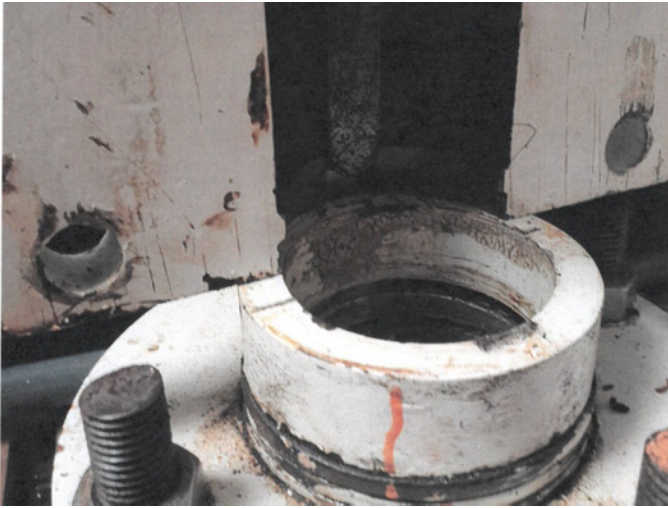
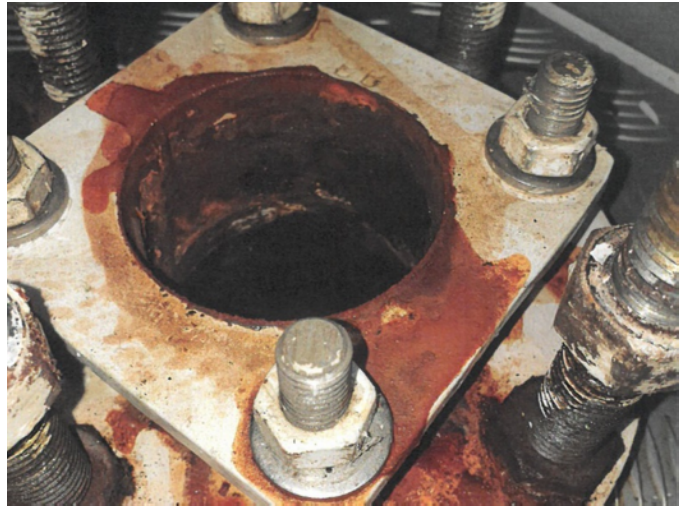
Rudders removal

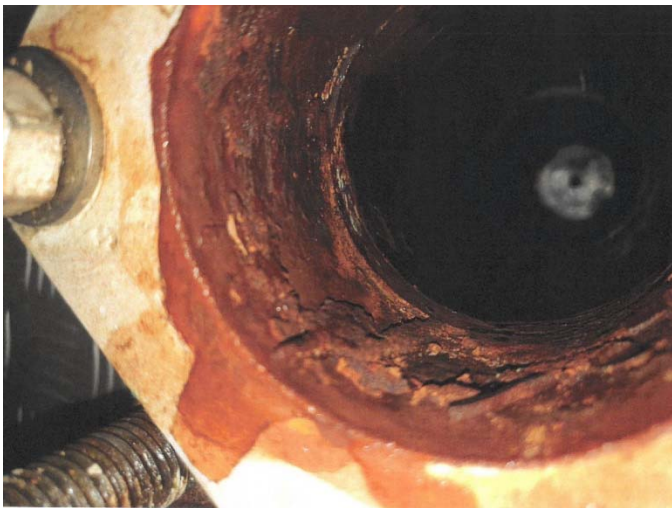
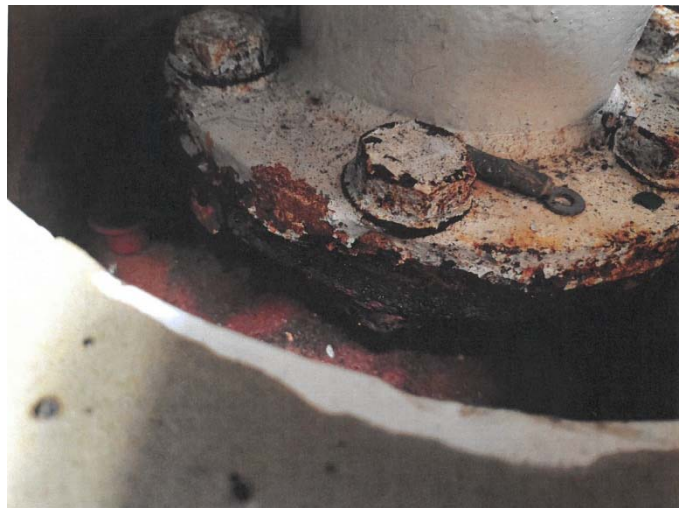
Rudders removal

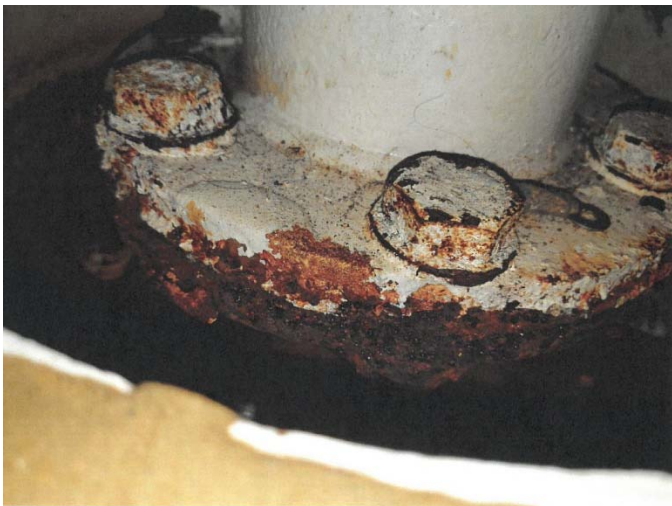
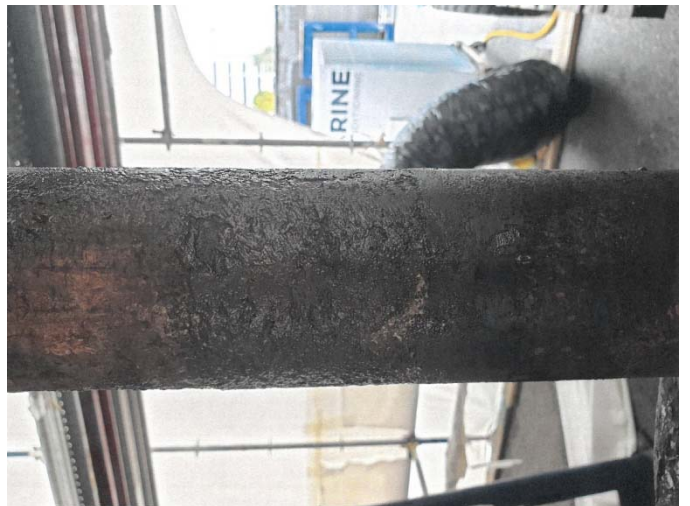
Rudders removal

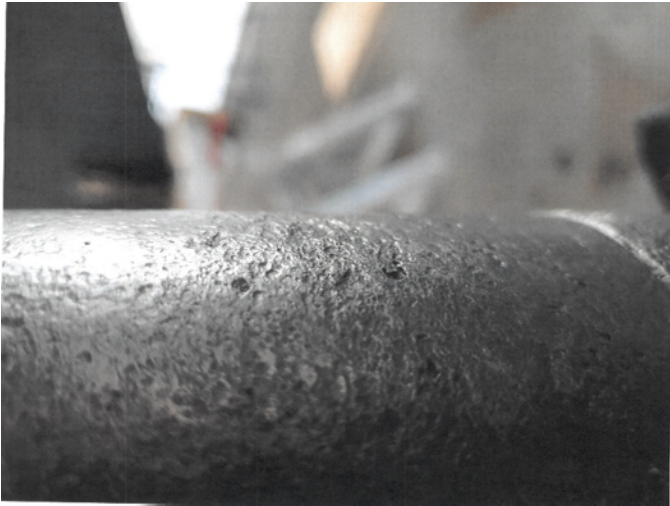
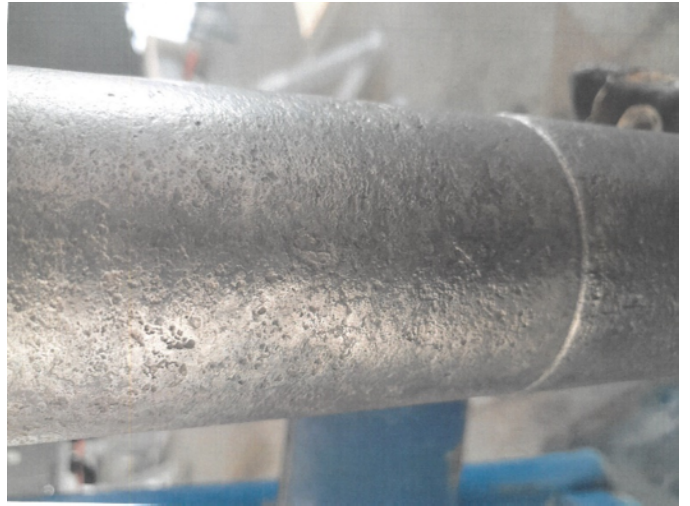
After rudders removed stocks and bearings have been cleaned. Rudders shafts found with deep cavities and pittings. Measurements taken of bearings and stock. Rudder stocks must be repaired.

Rudder stocks pitting

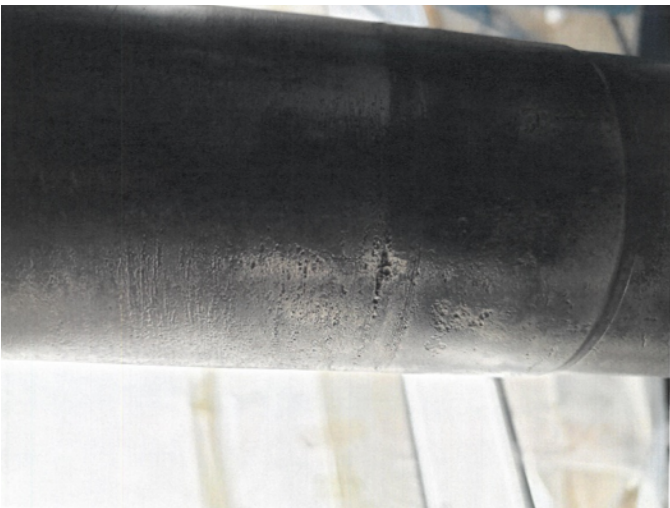
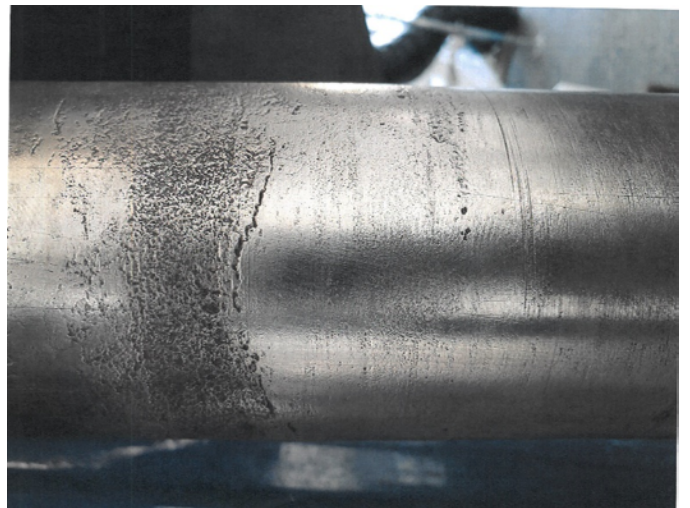
Rudder stocks pitting

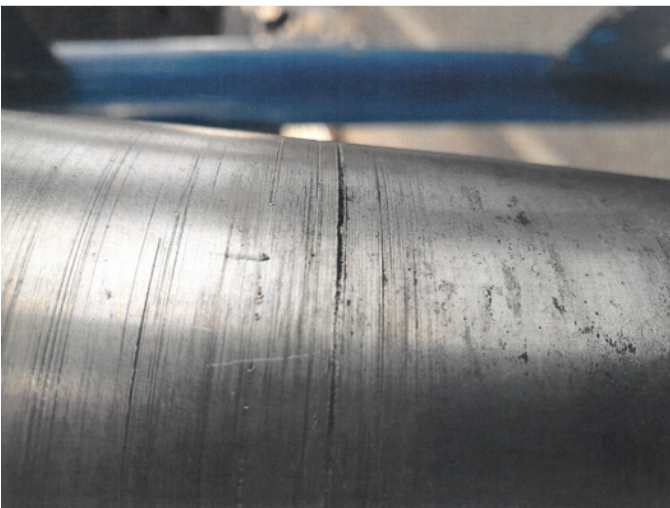
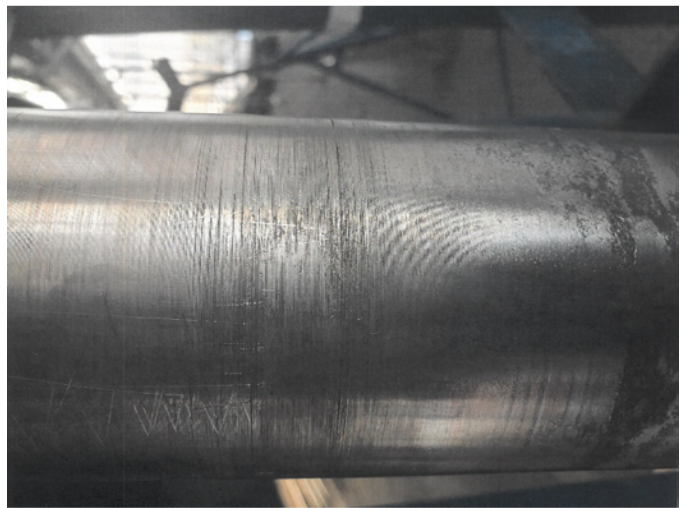
Rudder stocks pitting

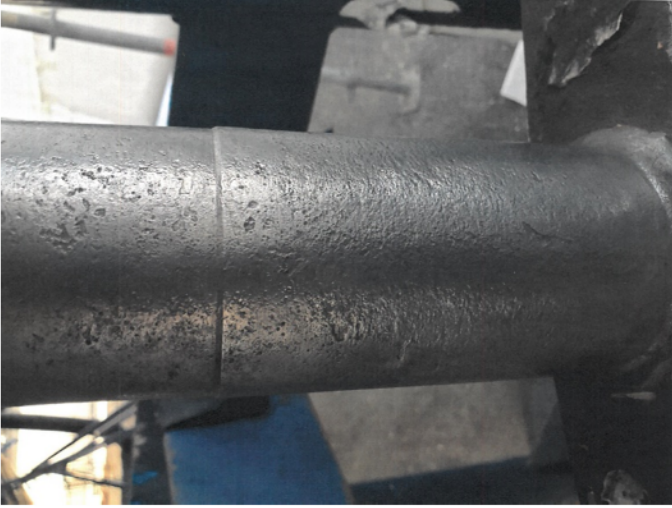
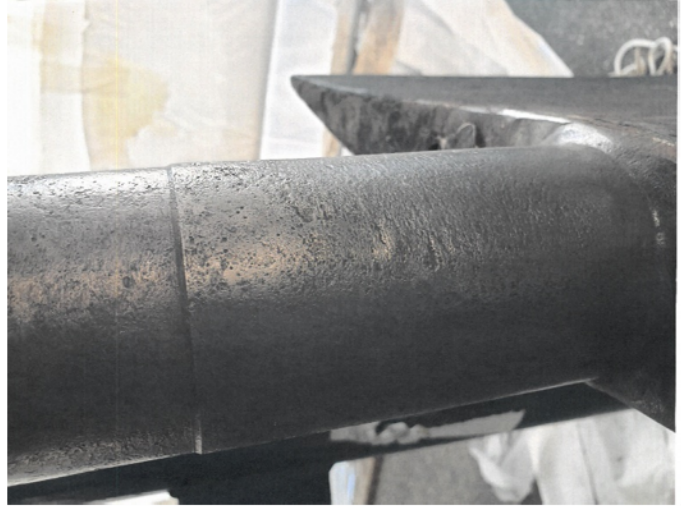
Rudder stocks pitting

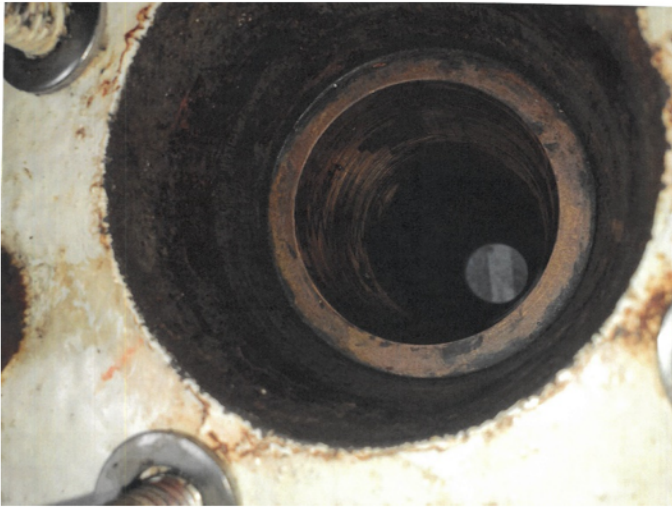
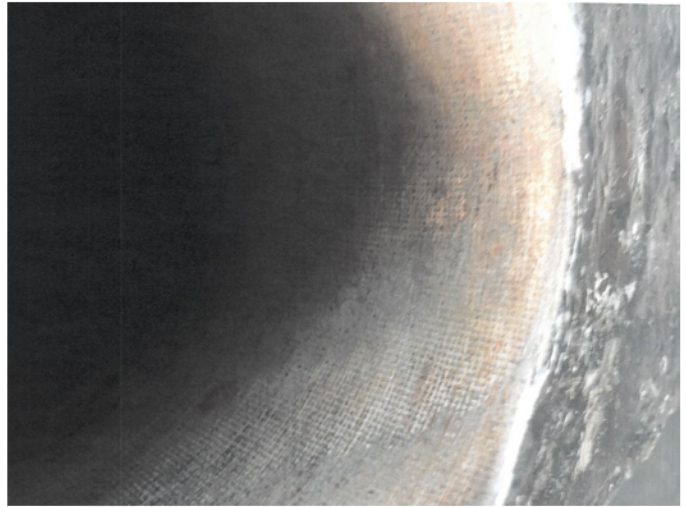
Rudder stocks pitting

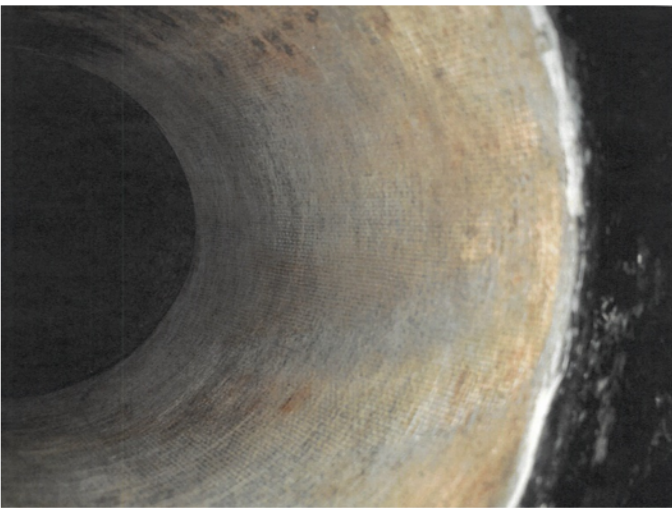
Rudder stocks pitting
